Manhole Inspection Summary

Manhole # S27G__017MH

Inspection ☐ Is Incomplete Rating: **4) Poor**

Location Address: **931 W Fayette(alley behind house)**

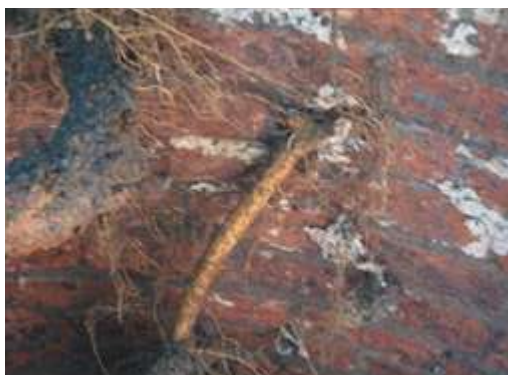
Defect 5

Condition: ☐ Sound ☐ Cracked ☒ **Root Intrusion** ☐ Loose Brick ☐ Deteriorated

Infiltration: ☐ None ☐ Joint ☐ Cracks ☐ Mortar ☒ **Roots** ☒ **Wall**

corbel root grwoth/ evidence of infiltration

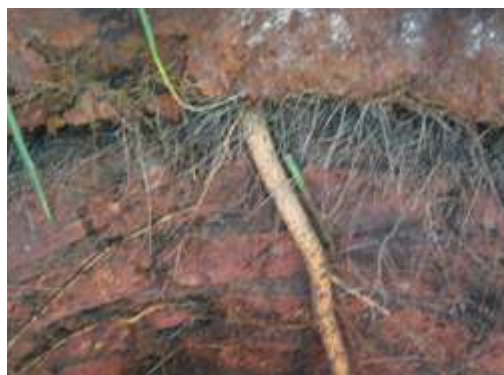
Defect 4

frame-chimney growth/ Source of chimney infiltration

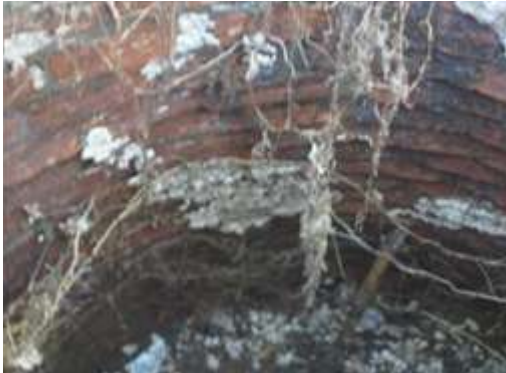
Defect 3

Condition: ☐ Sound ☐ Cracked ☒ **Root Intrusion** ☐ Loose Brick ☐ Deteriorated

Infiltration: ☐ None ☐ Joint ☐ Cracks ☐ Mortar ☒ **Roots** ☒ **Wall**

barrel root growth, evidence of infiltration, barrel flow wall, corbel flow wall

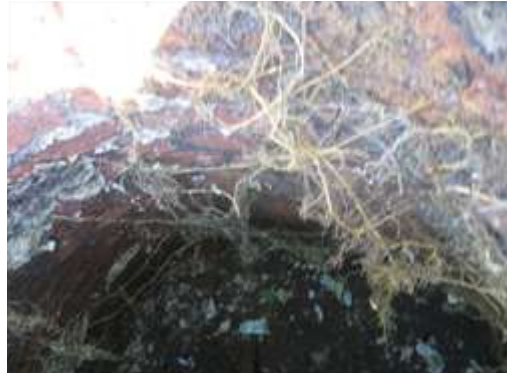
Defect 2

corbel and barrel root intrusion

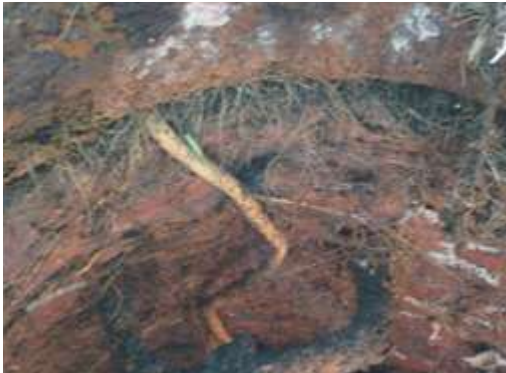
Defect 1

Condition: ☐ Sound ☐ Cracked ☒ **Root Intrusion** ☐ Loose Brick ☐ Deteriorated

Infiltration: ☐ None ☐ Joint ☐ Cracks ☐ Mortar ☐ Roots ☒ **Wall**

chimney root intrusion

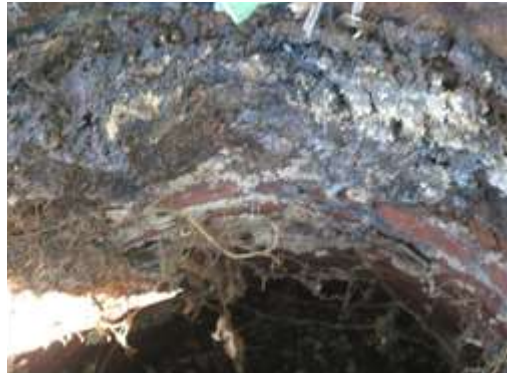
Frame offset

chimney cond deteriorated

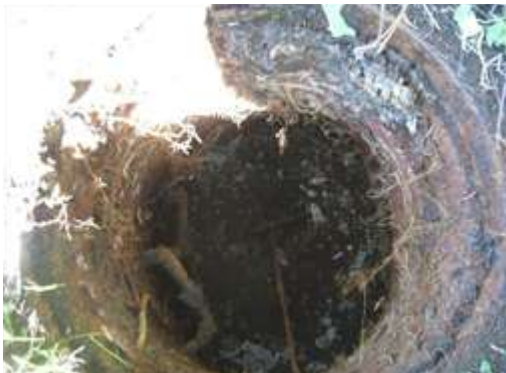
Defect 6

Condition: ☐ Sound ☐ Cracked ☐ Root Intrusion ☐ Deteriorated ☐ Leaks ☒ **Debris**

Bench and Channel Debris
